Macintosh IIsx Hard Drive Replacement

The Macintosh IIsi Uses a 50-Pin SCSI Drive, that doesn't need to be terminated while in single configuration.

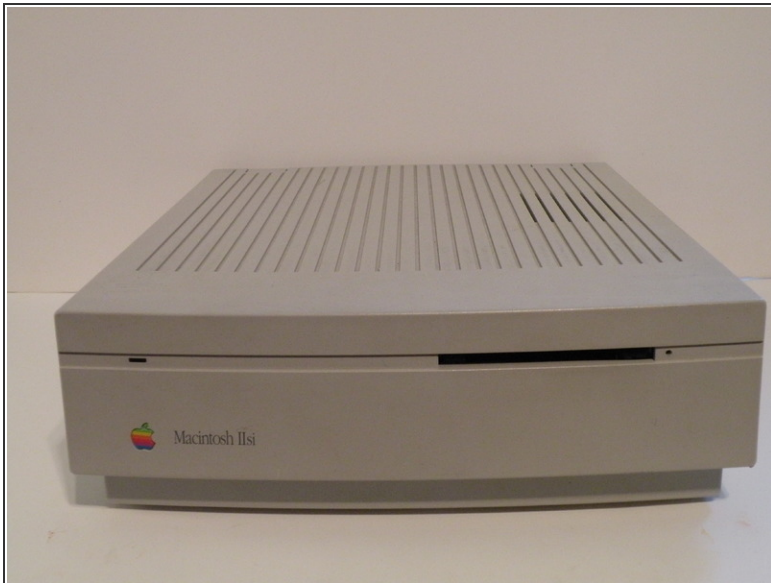
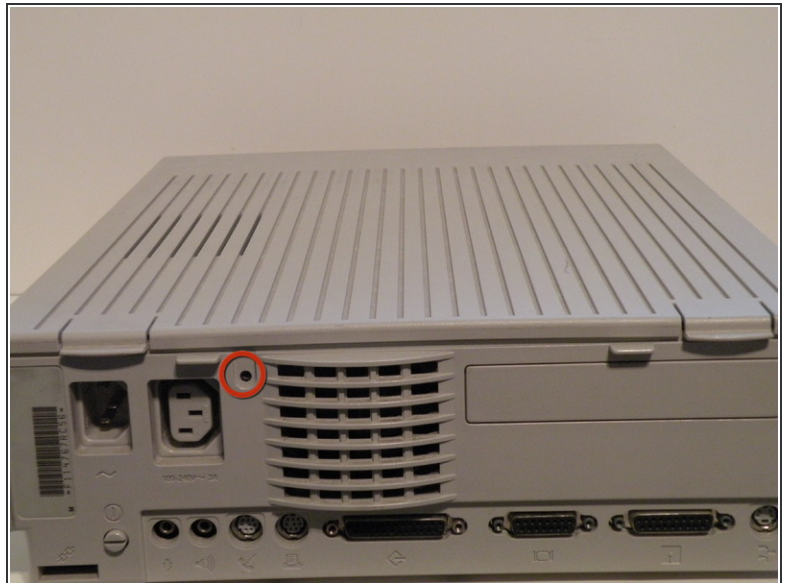
Step 1 — Top Case

- Start by turning the computer around, and remove this #0 Phillips Screw.

i There may or may not be a Phillips #0 screw here, depending on whether or not the computer has ever been serviced.

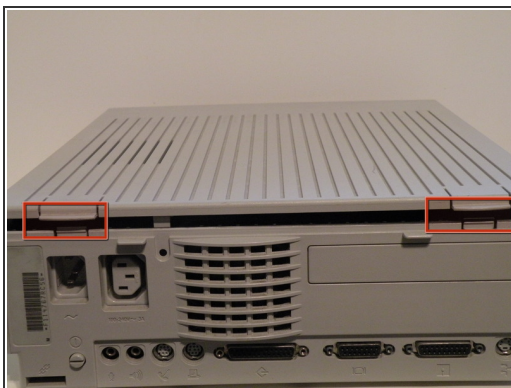
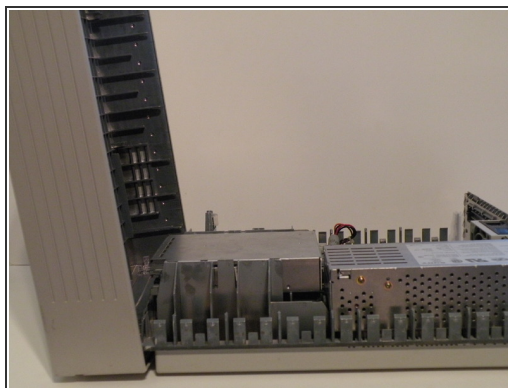
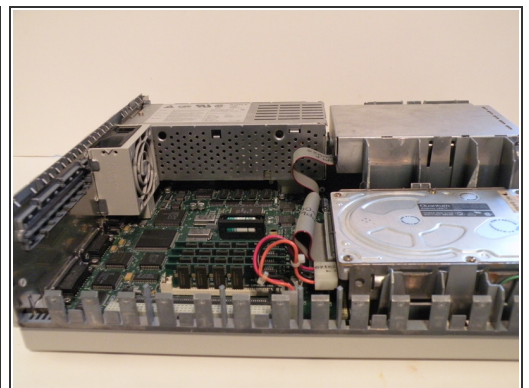
Step 2

- Now lift these two clips, and slowly pivot the case up.
- You can now separate the top of the computer from the rest of the machine.

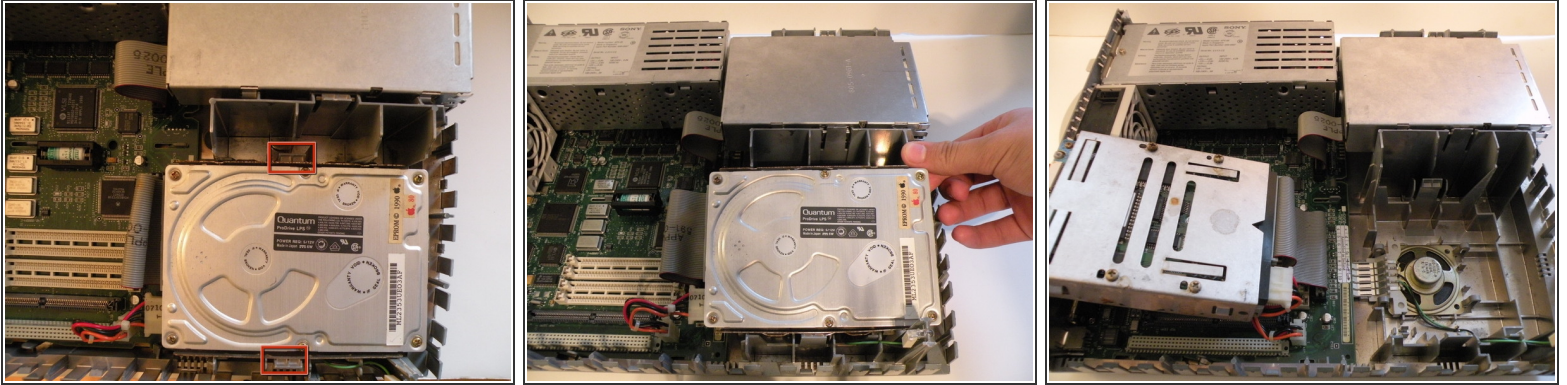
Step 3 — Hard Drive

- The Macintosh IIsx's hard drive is located adjacent to the ram and floppy drive.
- Start by pushing these two tabs out, and lifting the drive up.
- Then, flip the drive over, and remove the connection cables.

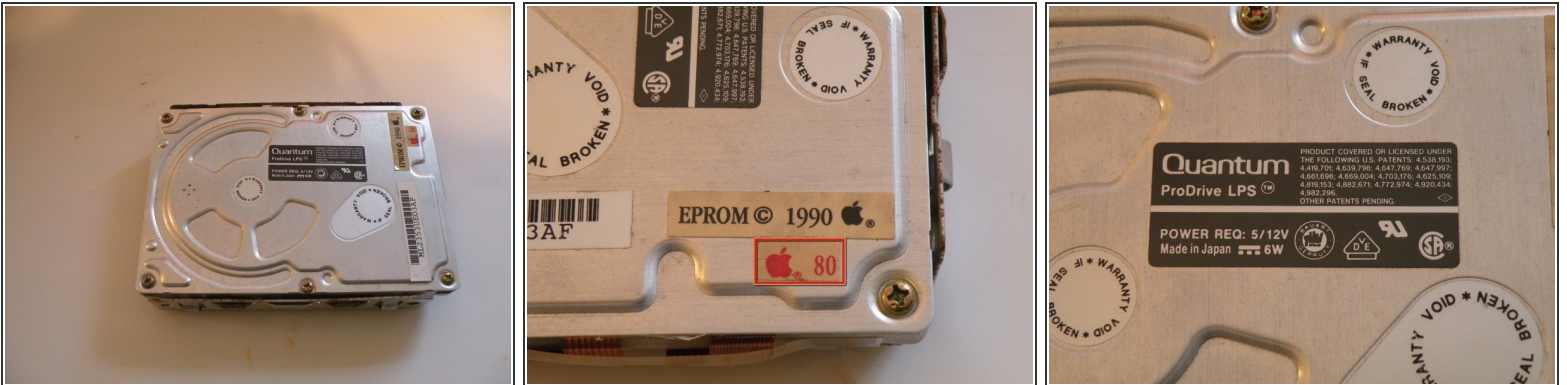
Step 4

- The hard drive: A Quantum ProDrive LPS, made in 1990, and surprisingly, it still works!
- This drive has an 80MB capacity, not very large by today's standards, but not bad way back then...
- Believe it or not, hard drive construction hasn't changed much in the last 20 years. Other than a few new interfaces, the form factor, 3.5" width and 4-Pin 12V/5V power connector has stayed the same.
